GE Appliances & Lighting Service Bulletin

February 2012

Laundry
Models:
GTUP270EM/GM

HL01-12

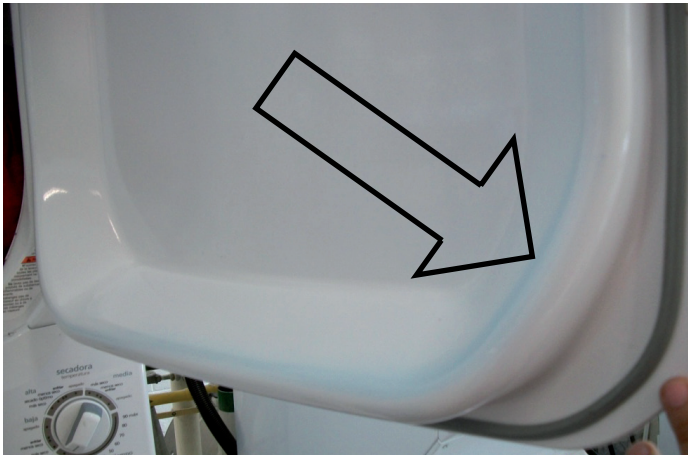
CURRENT DOOR

Clothes ripping during the drying cycle in the Unitized washer-dryer may be the result of an uneven gap between the dryer inner door and front panel. This may occur on units produced prior to January 2012 (AZ serial number).

The resolution for this issue is to replace the dryer door **WE10M151**. Current dryer door stock has been replaced with a new modified door which corrects the gap and prevents the issue from occurring. This issue is *not* caused by the trap duct grid (opening to the lint filter).
